# DeLorean Owners Association Regional Chapter 41

October 28, 1996

#### **Tech Notes**

## **Disassembly Continued**

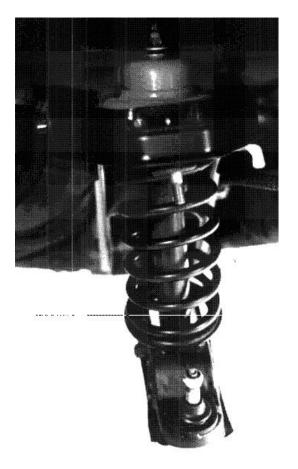
After the procedure outlined in the previous issue, the suspension should appear as in the photo below – the brake caliper and hub (51) are removed and only the snub axle (12) is left protruding from the steering knuckle (1) with the disk shield attached. Note the brake caliper suspended with a rope – do not let it hang from the hydraulic line. All the photos are of the right (passenger) front suspension assembly (the exploded-view diagram is of the **left** side).

The remaining disassembly should only be carried out if you have replacement ball-joints on hand. Separating the knuckle from the various ball-joints usually damages the ball-joints (or at the least thrashes the ball-joint boots).

Do **not** remove the shock absorber (35) before separating the ball joints (13, 15, 47) since the shock will solely support the lower suspension arm (31) once the knuckle (1) is removed (if the shock is severely damaged such that it may not support the lower suspension arm against the force of the spring (42), the lower suspension arm (31) must either be supported or a new shock put in place first).

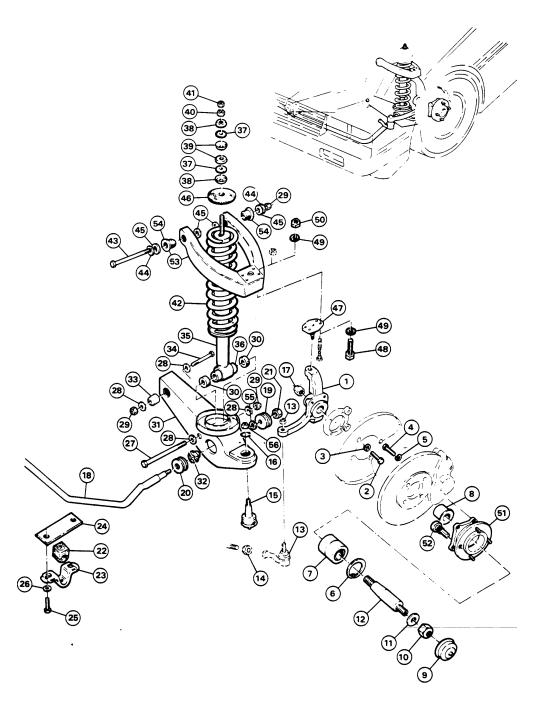
Repeat the procedure for the upper and lower ball joints (47 and 15). The nuts on these are quite tight and you might try soaking them in a penetrating oil overnight before starting the procedure. Again, these nuts did not seem to be metric and you should take care to use a wrench that is snug enough to avoid rounding the nuts. At this point, the setup should look as in the photo below.

Remove the upper wishbone control arm (53) by removing the 19mm nut and withdrawing the long bolt (43). Almost all the larger suspension bolts are 19mm, so the torque wrench you use for removing the wheels will come in handy. Keep track of where all the spacer washers (44 & 45) go for re-assembly. You should be left with just a coil spring, shock absorber and lower control arm as in the photo below.

The brake caliper can now be positioned out of the way better by suspending it near the front of the car. The hydraulic line previously passed between the coil spring and the knuckle preventing it from being positioned anywhere but near its mounting point. The tie rod can simply be positioned out of the way.

The tie rod end is easily removed from the tie rod by loosening the lock nut (14) and unscrewing the tie rod end. Although you might take care to count the number of turns it takes to remove the tie rod end, in practice you will need a front end alignment in any case after the procedure. You just want the front end straight enough to drive to the alignment shop afterwards.
